DIVINE DESIGN? SACKVILLE UNITED CHURCH AS A COMMUNITY CENTRE

Economic Feasibility Report

This document outlines a study conducted to determine if it is economically feasible and sustainable to operate the former Sackville United Church building as a community centre.

Report prepared by: Gwen Zwicker and Amanda Marlin

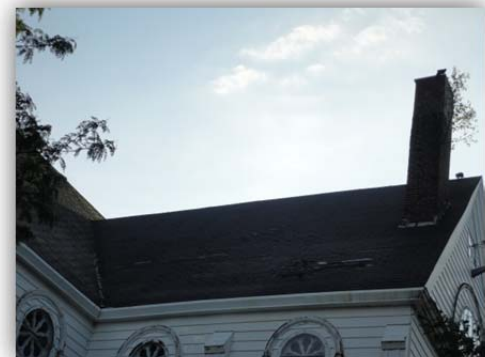
FIGURE 1: TREE GROWING IN CHIMNEY

- Oil tank replacements
- Kitchen upgrades
- Painting and siding repairs
- Masonry repairs to chimney (Figure 1)

No estimates have been made to repair or replace existing chimneys or walkways. An exterior visual of the chimney located behind the choir loft area shows a tree growing through the side of the chimney.

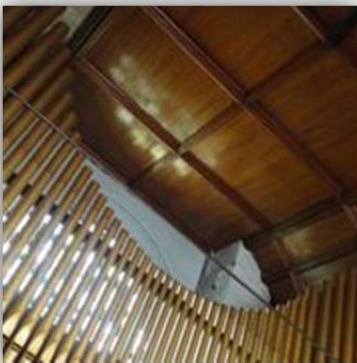
- One tension tie rod connection through the exterior wall shows stress in the wall finish (see Figure 2).

FIGURE 2: PART OF TENSION TIE ROD

It connects to vertical wood columns to laterally support the exterior walls and rafters. It is evident from the connection that this rod has not been tensioned for considerable time and the self weight of the rod has caused the stress signs on the interior wall....We do not have any major concerns here; however, we recommend these original rods be re-tensioned.

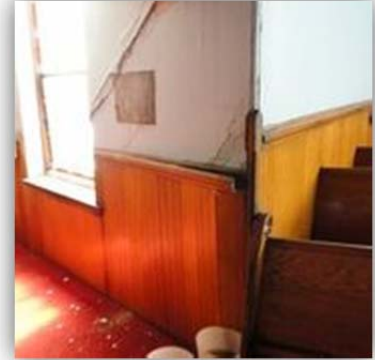
- The floor appears sound.
- The basement is in satisfactory condition and is dry except for one area that has some moisture problems.
- One tie rod connection at the exterior wall shows some stress in the wall finish.
- There are superficial cracks in the plaster which...are due to moisture penetration from the roof leaks and deteriorated window sills.
- There is some separation of the plaster in the walls at the four corners of the sanctuary (see Figure 3).

FIGURE 3: SEPARATION OF PLASTER AT CORNERS

1. Severely cracked plaster and apparent settlement in the corners of the sanctuary where the newer wings intersect the original building walls; and
2. One tension tie rod connection through the exterior wall shows stress in the wall finish.

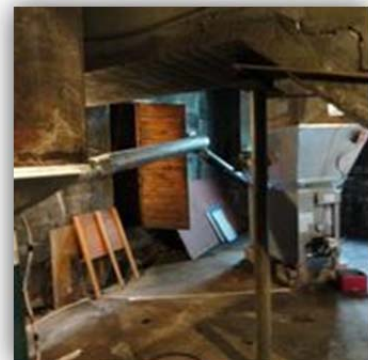
FIGURE 4: PART OF HEATING SYSTEM

The building is currently heated by two forced air oil furnaces (see Figure 4). Parts of the newer section are heated with electrical heat. With little insulation throughout the building and the rising cost of oil and electricity, the heating system is inefficient and costly.

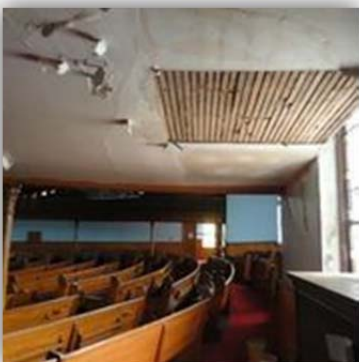
FIGURE 5: WATER DAMAGE TO CEILING

The interior of the sanctuary shows large pieces of the ceiling missing (see Figure 5), extensive cracked plaster and evidence of mold. Mold in the choir loft area is so extensive that there are groupings of fungus growing on the walls (see Figure 6). It is obvious that a lot of water damage has been sustained from a leaking roof.

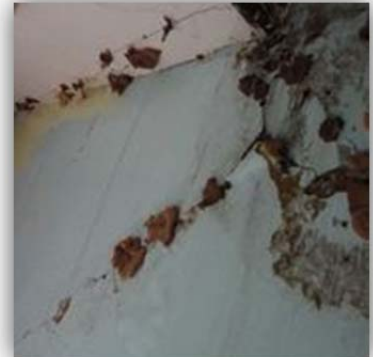
FIGURE 6: FUNGUS GROWING ON WALL

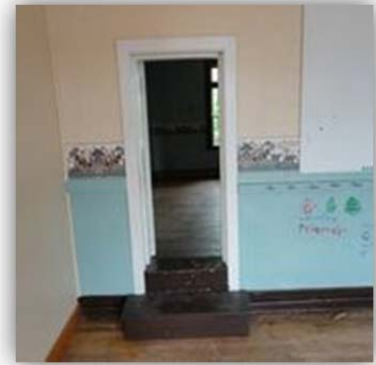
There are presently 4 rooms above the former Parlours. The supporting wall dividing the four (2 on each side) has a very small door opening and a step up, then down (possibly over a beam below) to access the two rooms on the other side (see Figure 7). This whole area would require a reconfiguration to allow access to the two connecting rooms plus washroom space for these offices. One of these rooms would become a washroom and a hallway access to the rooms behind it. In this configuration, there would be space for three offices measuring: 16 x 18 ft. (288 sq. ft.); 16 x 19 ft. (304 sq. ft.); and 16 x 19 ft. (304 sq. ft.). The present staircase would have to be removed and replaced with one which would allow access to the new washroom/hallway area and two offices but also allow access to the third office which currently exits to the sanctuary. A railing between this office and the sanctuary would have to be replaced because it is a safety hazard in its current configuration.

FIGURE 7: DOOR & STEP LINKING UPSTAIRS ROOMS
